Conductive Atomic Force Microscopy Application for Semiconductor Failure Analysis in Advanced Nanometer Process

Case Study: Nano-scale extra-shallow junctions affected with silicide-roughness-induced leakage issue

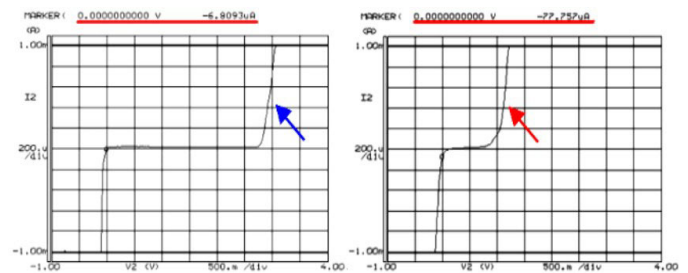
In this case study, a leakage current of 77uA at 0V was measured on the failing sample. This leakage current was compared with that of a good sample, which has leakage current lower than 6.8uA (Fig. 1). Both the low-static state (0V) and the I-V characteristic curves of the failing pin were different from those measured from the reference sample.

Figure 1.a: The (good) reference sample I/V curve showed the 6.8uA current at "Low state (0V)".

Figure 1.b: The I-V curve also show early turn "ON state", and "Low state leakage of 77uA@0V".

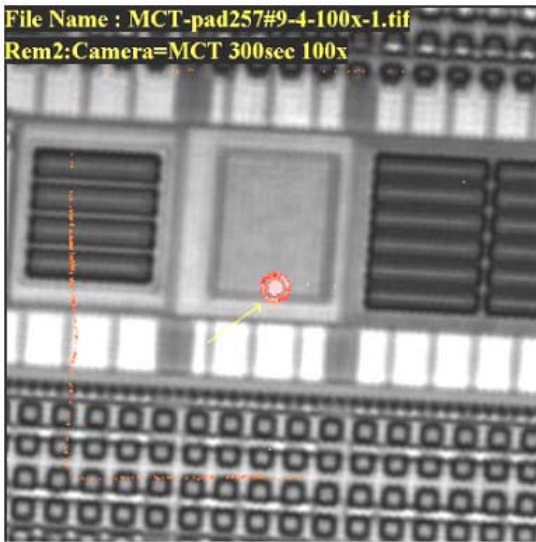
A backside MCT photoemission detector technique was performed, which attempted to localize the defect precisely. After zooming in to 1000x, a strong and solid MCT signal spot was found at an electrostatic discharge (ESD) device, as shown in Fig. 2.

Figure 2: 1000x Zoom, a precise Backside MCT spot was detected at the ESD protection device.

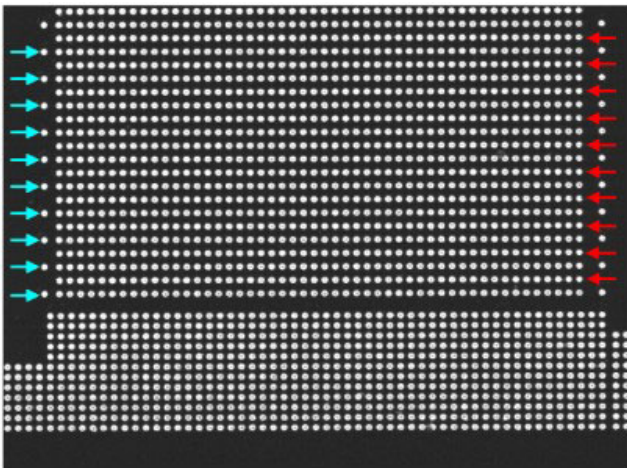
Passive voltage contrast (PVC) technique is used for detecting different potentials. However, in this advanced nanometer process sample, the extremely small contact size is insufficiently charged, so that PVC is ineffective because of its low sensitivity, as shown in Fig. 3.

Figure 3: Both n^+ diffusion contacts of odd rows (indicated by blue arrows) and p^+ contacts of even rows (indicated by red arrows) could not be distinguished by contrast difference using FIB PVC.

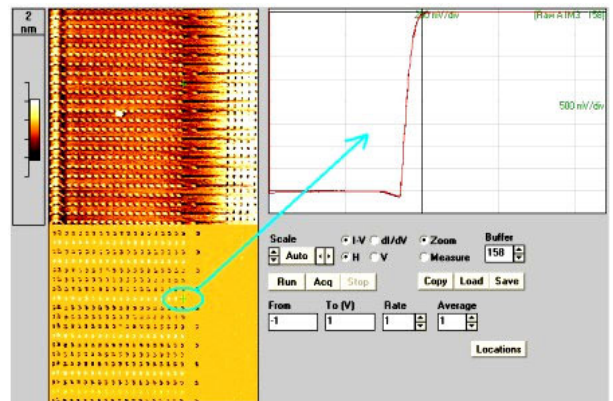
Figure 5: A good I-V spectroscopy measurement measured from a normal n^+ diffusion junction shown as bright white on the C_AFM current map..

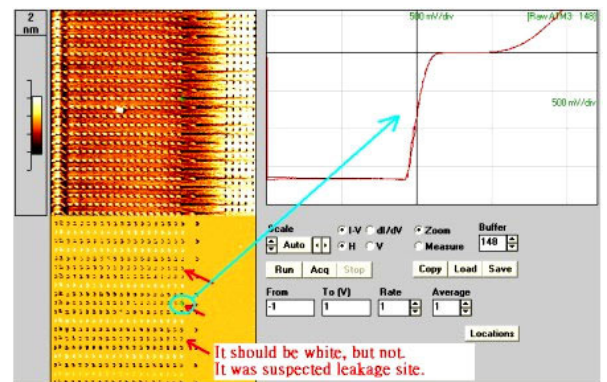
The suspected MCT spot was widely scanned for more accurate defect localization using C-AFM. There are three images generated simultaneously while scanning the sample surface using the C-AFM (Fig.4) . The top-left image is the AFM topography. The bottom-left image is the current mapping information and the bottom right image is the I/V spectroscopic curve taken at a point on the sample. On Fig. 5, a green cross in a blue circle indicates where the I-V spectroscopic measurement was performed on the sample, It shows the normal n^+ diffusion junction as a bright white-yellow colored contact (Fig. 5). Based on the abnormal dark black contact, a leakage issue was detected and was confirmed by I-V curve spectroscopy (Fig. 6). The curve is like that of a junction leakage issue, as shown in Fig. 6.

Figure 6: Three abnormal dark black contact rows were detected as leakage sites, which was confirmed by I-V curve spectroscopic measurement.

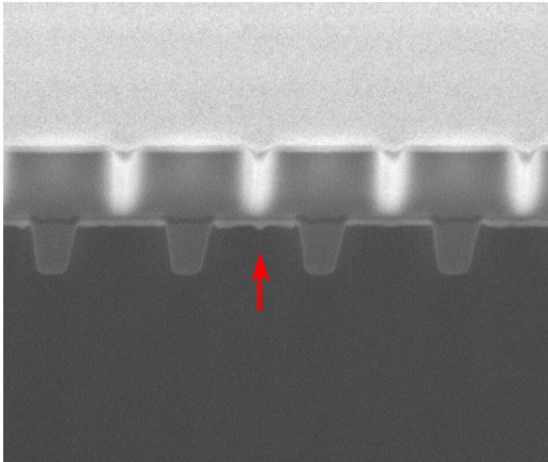
Based on the C-AFM current map information, a step-by-step X-SEM FIB technique is used to search for the suspected n+ diffusion surface. An obviously abnormal deeper silicide spike was found (Fig. 7) on the failing area. For advanced inspection, TEM was performed and the silicide spike depth of 65.4nm (Fig. 8) was measured, which is twice as average silicide roughness.

Figure 7: A silicide spiking at the suspected n+ diffusion contact row was located by step-by-step FIB x-sectioning.

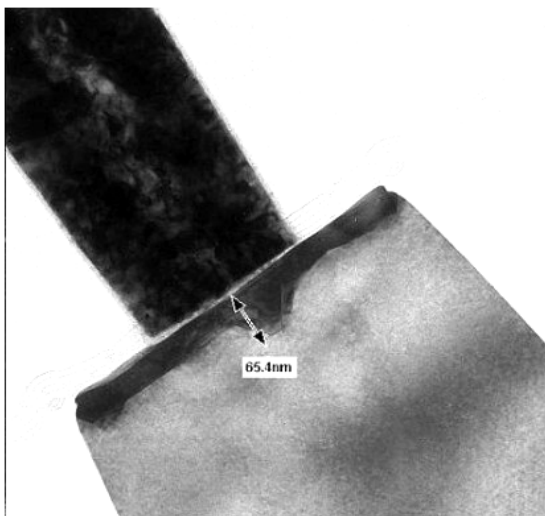
Figure 8: The abnormal silicide spike was measured as 65.4nm.

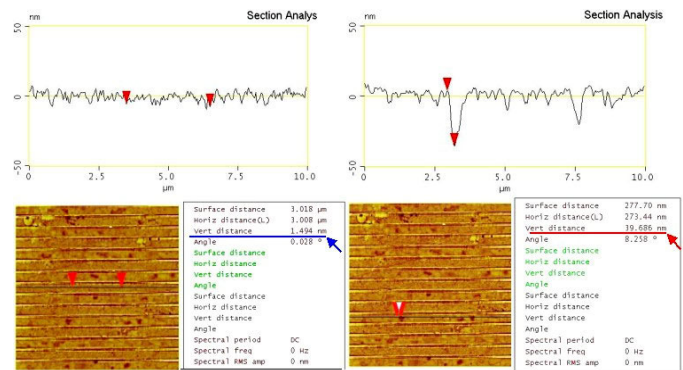
On the failing sample, after removing the cobalt silicide using dilute HF, the surface roughness distribution and geometry were measured using AFM. It was determined that the surfaces of the p+ diffusion rows were smoother than the n+ diffusion rows and that they had fewer dark black cavities. The p+ vertical profile measurement was about 1.5nm, and the n+ diffusion vertical measurement was about 40nm, as shown in Fig. 9.

Figure 9: AFM Topographical Images: the left shows the p+ diffusion surface afm image with vertical profile measurement of 1.494nm and the right afm image shows the dark black surface cavities of the failing n+ diffusion. This had a vertical path of 39.686nm

Fig. 9 shows the AFM topographical image of the failing n+ diffusion with several deep surface cavities. After the silicide process, the cavities were formed like a leakage valley. There is a high-risk leakage source for an extra-shallow junction transistor. As the process progresses into the nano scale, the material selectivity for extra shallow junctions needs to be tightly controlled.
